TOTAL DRINKING FOUNTIAN THROUGH OUT DISTRICT

McKinley ES Wall Mounted Drinking Fountain Inspection Survey

McKinley ES INTERIOR & EXTERIOR Drinking Fountain Inspection Survey

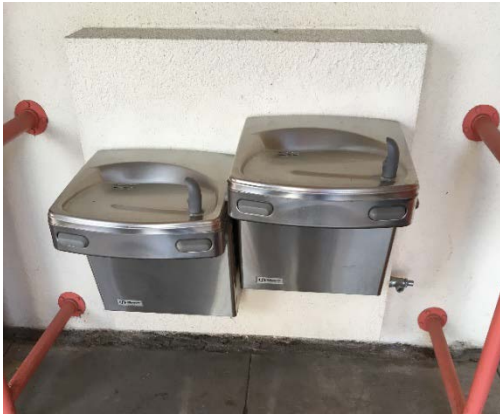
Picture #1

<i>Location</i>	<i>Brand</i>	<i>Year</i>	<i>Type</i>	<i>Operable</i>	<i>Pic Ref #</i>	<i>Ada</i>	<i>Int/Ext</i>	<i>Condition</i>
SOUTH WALL BY ROOM 100	HAWS	2000'S	STANDARD	YES	1	YES	EXTERIOR	GOOD
EAST WALL LIBRARY	SUNROC	90'S	STANDARD	YES	2	YES	EXTERIOR	OUTDATED
EAST WALL LIBRARY	?	2000'S	BOTTLE FILLER	YES	3	YES	EXTERIOR	GOOD
SOUTH WALL PLAYGROUND	ELKAY	2000'S	BOTTLE/BUBBLER	YES	4	YES	EXTERIOR	GOOD
SOUTH WALL PLAYGROUND	SUNROC	90'S	DOUBLE BUBBLER	YES	5	YES	EXTERIOR	OUTDATED
BETWEEN ROOM 108/109	SUNROC	90'S	STANDARD	NO	6	YES	INTERIOR	REPLACE
PLAYGROUND BATHROOM	SUNROC	90'S	HIGH/LOW	YES	7	YES	EXTERIOR	GOOD
BETWEEN ROOMS 209/208	SUNROC	90'S	STANDARD	YES	8	YES	INTERIOR	OUTDATED
EAST WALL PRE-K	SUNROC	90'S	STANDARD	YES	9	YES	EXTERIOR	OUTDATED
NORTH WALL PRE-K PLAYGROUND	SUNROC	90'S	HIGH/LOW	YES	10	YES	EXTERIOR	OUTDATED

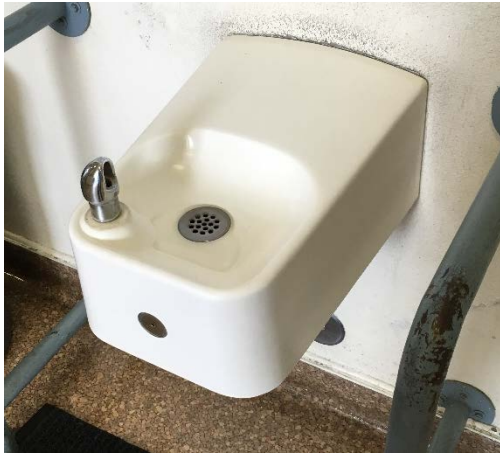
Picture #1

<i>Location</i>	<i>Brand</i>	<i>Year</i>	<i>Type</i>	<i>Operable</i>	<i>Pic Ref #</i>	<i>Ada</i>	<i>Int/Ext</i>	<i>Condition</i>
NORTH WALL BY ADMIN	SUNROC	90'S	STANDARD	YES	1	YES	INTERIOR	OUTDATED
NORTH WALL LUNCH AREA	ELKAY	2000'S	BUBBLER/BOTTLE	YES	2	YES	EXTERIOR	GOOD
SOUTH WALL PE BUILDING	ELKAY	2000'S	BUBBLER/BOTTLE	YES	3	YES	EXTERIOR	GOOD
SOUTH WALL PE BUILDING	SUNROC	2000'S	STANDARD	NO	4	YES	EXTERIOR	REPLACE
EAST WALL BETWEEN RESTROOMS	SUNROC	90'S	STANDARD	YES	5	YES	EXTERIOR	OUTDATED
EAST WALL NEAR ROOM 12	HAWS	90'S	STANDARD	YES	6	YES	EXTERIOR	OUTDATED
WEST WALL KINDER	SUNROC	2000'S	STANDARD	YES	7	YES	INTERIOR	GOOD
WEST WALL KINDER SEPARATE BLDG	HAWS	90'S	STANDARD	YES	8	YES	INTERIOR	OUTDATED
SOUTH WALL UPSTAIRS BY RM 37	HAWS	90'S	STANDARD	YES	9	YES	INTERIOR	OUTDATED
SOUTH WALL UPSTAIRS BY RM 35	SUNROC	90'S	STANDARD	YES	10	YES	EXTERIOR	OUTDATED
NORTH WALL BY RM 6	HAWS	90'S	STANDARD	YES	11	YES	EXTERIOR	OUTDATED

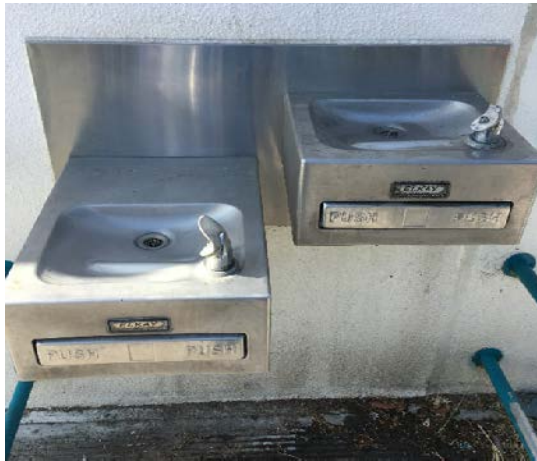
Picture #1

Roosevelt ES Wall Mounted Drinking Fountain Inspection Survey								
Location	Brand	Year	Type	Operable	Pic Ref #	Ada	Int/Ext	Condition
NORTH WALL BY PE OFFICE	ELKAY	2000's	HI/LOW	YES/NO	1	YES	EXTERIOR	NON OP
WEST WALL BUILDING B	HAWS	2000's	HI/LOW	YES	2	YES	EXTERIOR	GOOD
WEST WALL BUILDING E	HAWS	2000's	HI/LOW	YES	3	YES	EXTERIOR	GOOD
WEST WALL BUILDING G	HAWS	2000's	HI/LOW	YES	4	YES	EXTERIOR	GOOD
NORTH WALL KINDER YARD	HAWS	2000's	HI/LOW	YES	5	YES	EXTERIOR	GOOD
EAST WALL BUILDING G	HAWS	2000's	HI/LOW	YES	6	YES	EXTERIOR	GOOD
SOUTH WALL BUILDING H	HAWS	2000's	HI/LOW	YES	7	YES	EXTERIOR	GOOD
NORTH WALL IN CAFETERIA	ANSLEY T	2000's	BOTTLE/BUBBLER	YES	8	YES	INTERIOR	GOOD
EAST WALL BUILDING E	HAWS	2000's	HI/LOW	YES	9	YES	EXTERIOR	GOOD
EAST WALL BUILDING B	HAWS	2000's	HI/LOW	YES	10	YES	EXTERIOR	GOOD
EAST WALL BY ROOM 39 (BUNGALOW)	HAWS	2000's	STANDARD	YES	11	YES	EXTERIOR	GOOD
SOUTH BY BUNGALOW 24	?	90's	STANDARD	YES	12	YES	EXTERIOR	GOOD

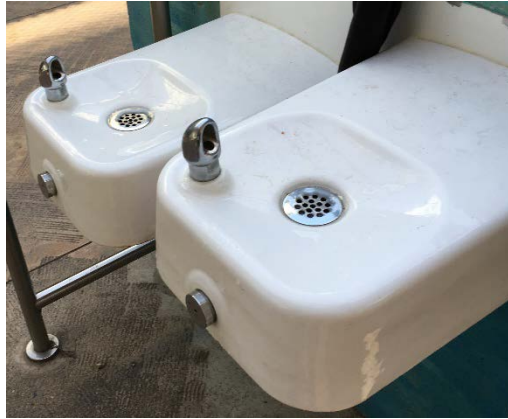
Picture #2

Point Dume ES Wall Mounted Drinking Fountain Inspection Survey								
Location	Brand	Year	Type	Operable	Pic Ref #	Ada	Int/Ext	Condition
NORTH WALL NEAR PE STORAGE	SUNROC	90'S	3 BUBBLER	YES	1	YES	EXTERIOR	OUTDATED
WEST WALL LUNCH AREA	SUNROC	90'S	HI/LOW	YES	2	YES	EXTERIOR	OUTDATED
EAST WALL FIELD AREA	SUNROC	90'S	3 BUBBLER	YES	3	YES	EXTERIOR	OUTDATED
EAST WALL KINDER	SUNROC	90'S	SMALL STANDARD	YES	4	YES	EXTERIOR	OUTDATED
Point Dume ES INTERIOR & EXTERIOR Drinking Fountain Inspection Survey

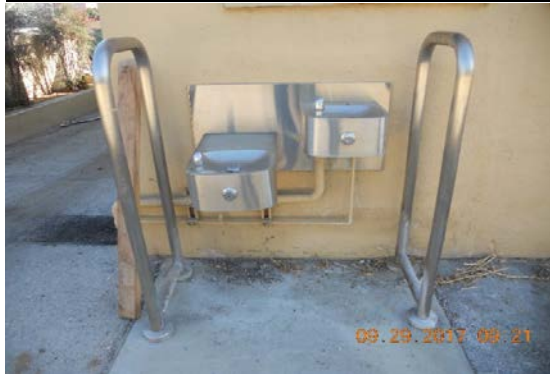
Picture #1

Olympic HS Wall Mounted Drinking Fountain Inspection Survey								
<i>Location</i>	<i>Brand</i>	<i>Year</i>	<i>Type</i>	<i>Operable</i>	<i>Pic Ref #</i>	<i>Ada</i>	<i>Int/Ext</i>	<i>Condition</i>
REAR OF CLASSROOM 307	SUNROC		STANDARD	YES	1	YES	EXTERIOR	OUTDATED
NEAR SCIENCE LAB 100	HAWS		STANDARD	YES	2	YES	EXTERIOR	REPLACE
ROOM 6	HAWS		STANDARD	YES	3	YES	EXTERIOR	OUTDATED
LUNCH AREA	SUNROC		STANDARD	YES	4	YES	EXTERIOR	REPLACE
Olympic HS INTERIOR & EXTERIOR Drinking Fountain Inspection Survey

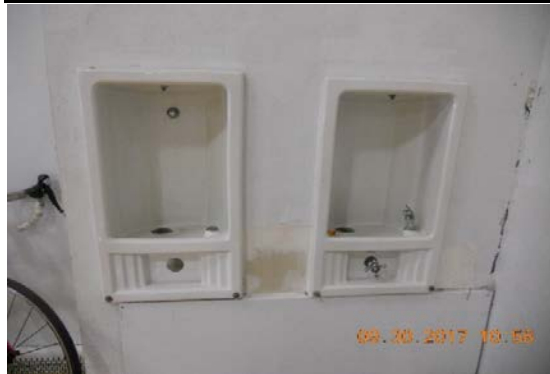
Picture #1

Santa Monica HS Wall Mounted Drinking Fountian Inspection Survey								
Location	Brand	Year	Type	Operable	Pic Ref #	Ada	Int/Ext	Condition
SG120 SOUTH GYM	?		STANDARD	YES/NO	1	NO	INTERIOR	REPLACE
N140 NORTH GYM	HAWS		STANDARD	YES	2	YES	INTERIOR	GOOD
N140 NORTH GYM	ELKAY		STANDARD	YES	3	NO	EXTERIOR	GOOD
M104 MUSIC	SUNROC		STANDARD	YES	4	YES	EXTERIOR	OUTDATED
C100 DINING ROOM	SUNROC		STANDARD	YES	5	YES	INTERIOR	OUTDATED
H119 HISTORY	SUNROC		STANDARD	YES	6	YES	INTERIOR	OUTDATED
H105 HISTORY	SUNROC		STANDARD	YES	7	YES	INTERIOR	OUTDATED
H208 HISTORY	SUNROC		STANDARD	YES	8	YES	INTERIOR	OUTDATED
H214 HISTORY	SUNROC		STANDARD	YES	9	YES	INTERIOR	OUTDATED
L112 LANGUAGE	HAWS		STANDARD	YES	10	YES	INTERIOR	REPLACE
L210 LIBRARY	SUNROC		STANDARD	YES	11	YES	INTERIOR	OUTDATED
E113 ENGLISH	SUNROC		STANDARD	YES	12	YES	INTERIOR	OUTDATED
E105 ENGLISH	SUNROC		STANDARD	YES	13	YES	INTERIOR	OUTDATED
E201 ENGLISH	SUNROC		STANDARD	YES	14	YES	INTERIOR	OUTDATED
