October 7, 2019

Subject: **STRUCTURAL INVESTIGATION OF THE LUNADA BAY LITTLE LEAGUE
SNACK SHOP - PALOS VERDES PENINSULA USD**

It is our understanding that the Lunada Bay Little League Snack Shack building, Division of the State Architect (DSA) Application No. 03-102808, was constructed without DSA's oversight thus was subsequently not closed-out. As part of DSA's request from the District, we performed a structural investigation of the building. Our structural investigation included review of available record drawings, performance of a visual site observation, and preparation of this structural report outlining out structural findings and recommendations.

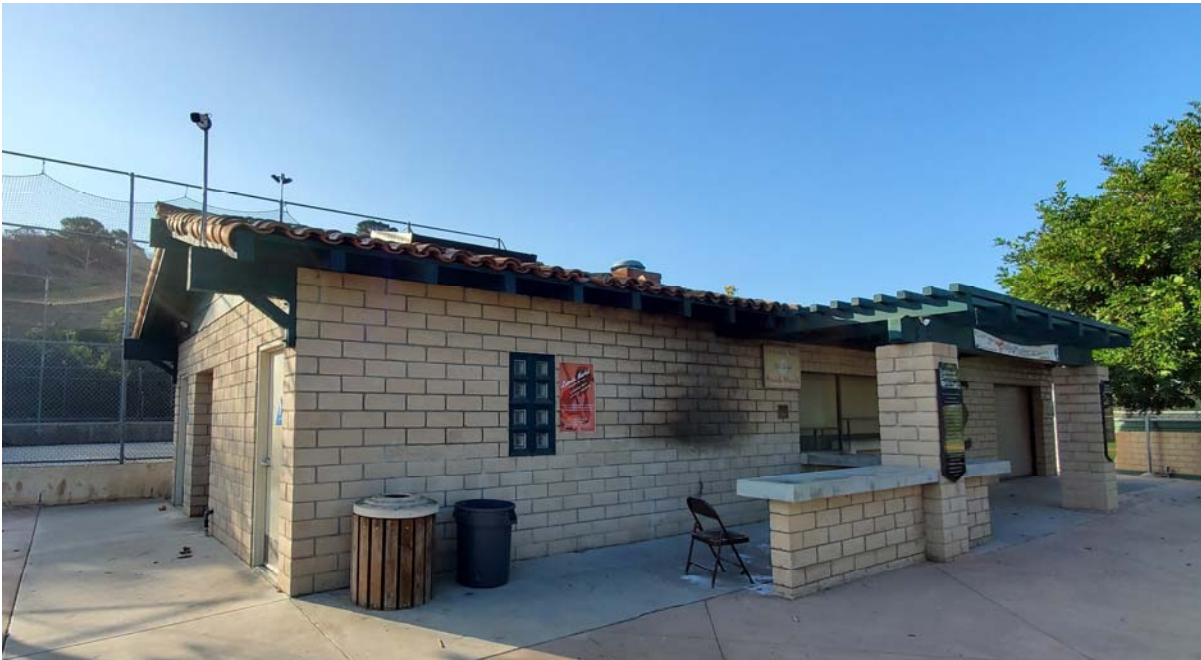
As shown in the photograph below, the existing building is a 24'-0" wide by 60'-0" long one-story structure. The perimeter walls and two interior partition walls are 8" wide reinforced slump block walls, and the roof is a wood framed two-way pitched mission tile roof with an approximate ridge height of 14 feet. On the east side is a timber framed trellis covering the serving windows.

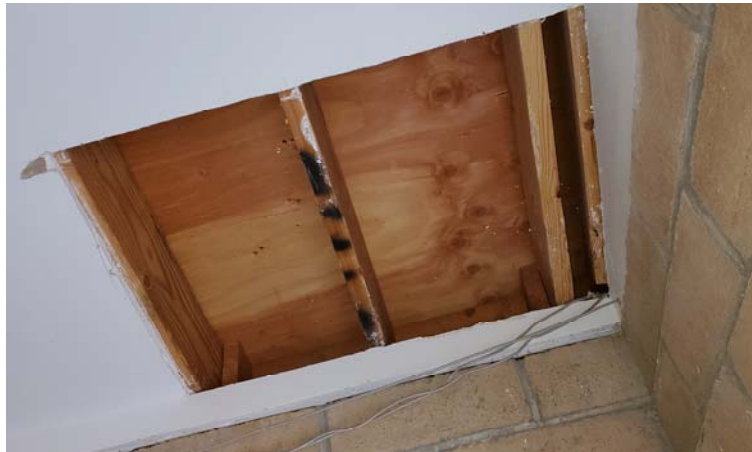
The existing roof framing system appears to be constructed of plywood sheathing nailed on to 2x8 roof rafters spaced at 16" on-center as shown in the photograph to the right. The roof rafters are supported by 3x wood sill plates on top of the block walls at the eaves and at the ridge supported by a glued-laminated beam. The glued-laminated beam is supported by either tubular steel or 6x6 wood posts.

Based on our review of the DSA-approved drawings and visual observation of the exposed conditions, it appears that the as-built existing roof framing system substantially deviates from the DSA-approved design. We anticipated that the existing roof framing system will need to be either seismically strengthened or replaced in its entirety to provide the vertical and lateral (seismic) capacity to meet the California Building Code minimum structural requirements.

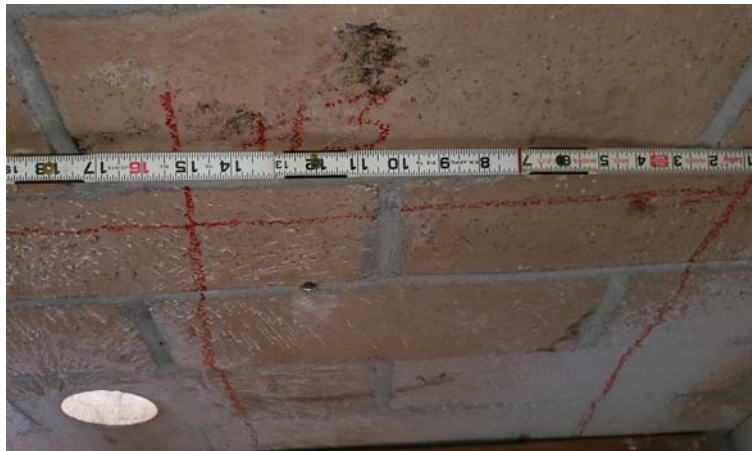
The existing perimeter wall and two interior partition walls are constructed of 8" wide slump block with vertical and horizontal reinforcing detected via non-destructive methods as depicted by the red lines in the photograph to the right. However, the reinforcing steel size and placement within the wall thickness could not be determined.

The existing block walls and foundations are likely to be structurally adequate since it is a relatively lightly loaded building structure with a regular structural floor plan. However, these elements will still need to be fully verified once more as-built information is gathered of the existing reinforcing steel.

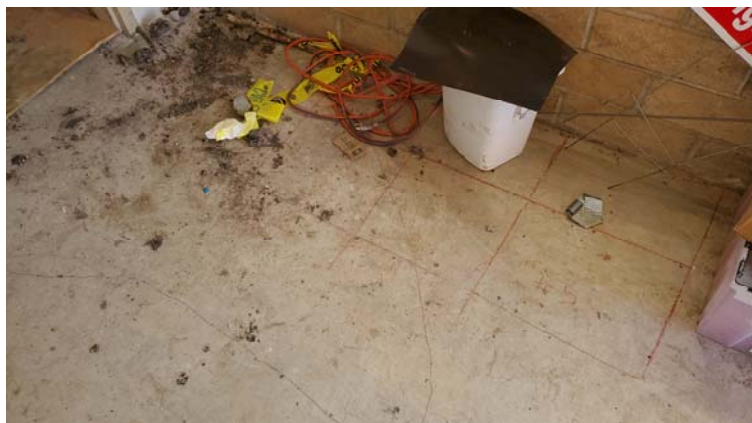
The existing concrete slab-on-grade was also tested to determine if reinforcing steel was present. As depicted by the red lines in the photograph to the right, the slab-on-grade has reinforcing placed in two directions. However, the reinforcing steel size and placement within the slab thickness could not be determined.

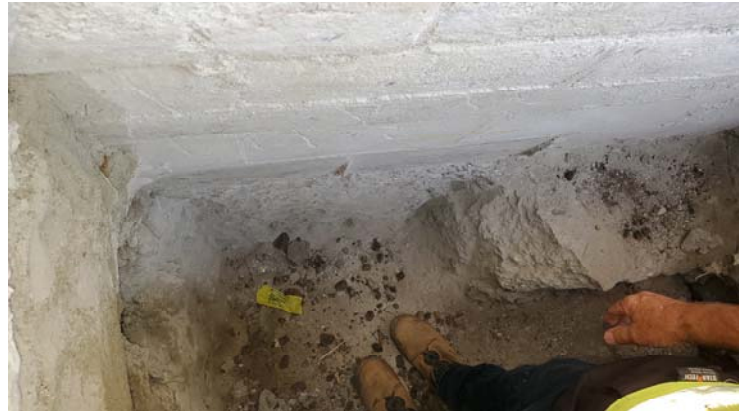
The existing block wall concrete foundation was exposed at one location as shown in the photograph to the right. The existing foundation was x-rayed, and it was detected that reinforcing steel was present. However, the size and exact location could not be determined by the x-ray method.

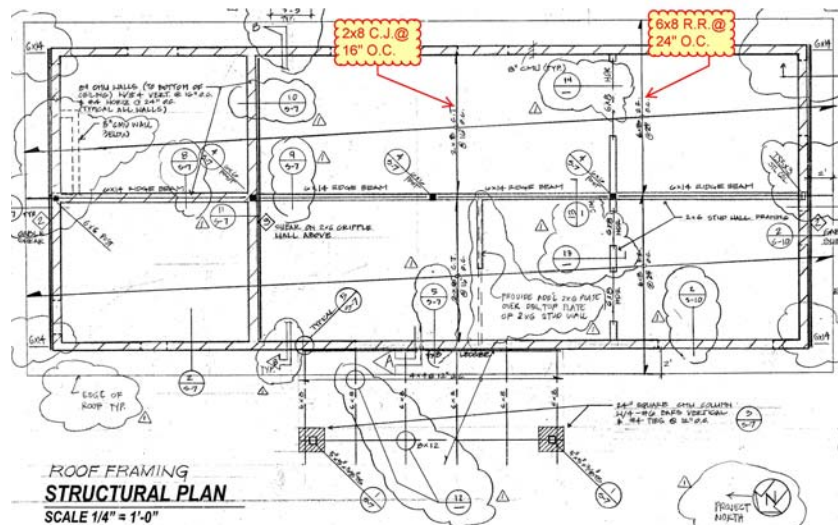
As indicated in the record drawing roof framing plan to the right, the existing roof framing system was to be constructed of 6x8 roof rafters (R.R.) spaced at 24" on-center. Instead, the existing roof rafters are 2x8 spaced at 16" on-center. Also, hardware such as the 2 1/16" wide Simpson MSTI ridge steel straps specified on the drawings to tie the 6x8 framing would not be recommended for installation on the existing the 1 1/2" wide 2x8 framing if installed.

The 2x8 at 16" on-center hard lid ceiling joist (C.J.) framing system serving to tie the interior wood framed walls and perimeter block walls together was not constructed.

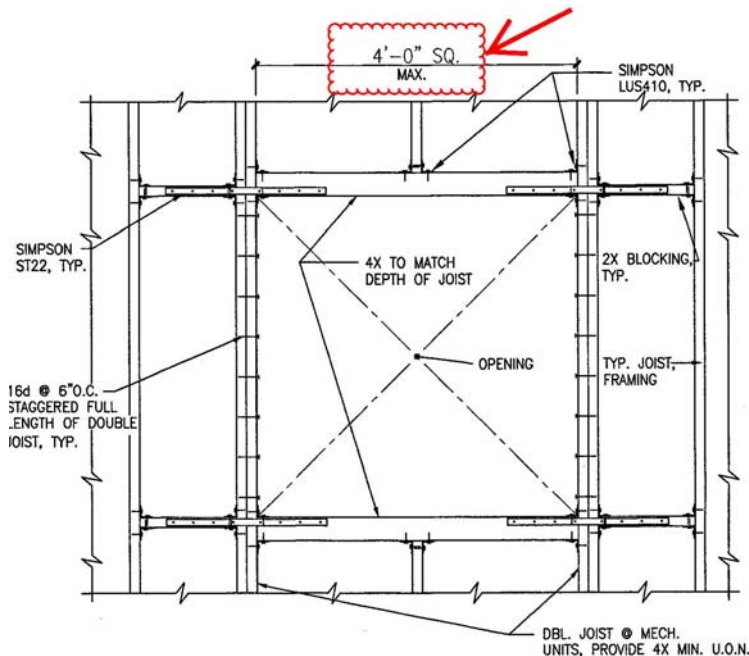
5 OPENING IN ROOF
N.T.S.

The two existing roof skylights installed are larger than the maximum 4'-0" opening size as shown on the DSA-approved typical drawing detail attached to the right. It is unknown how the skylight opening framing was reinforced or if straps were installed. It should also be noted that no skylights are shown on the DSA-approved roof framing plan. The current skylights are large and would require the roof seismic diaphragm to be reinforced.
