Created: Mon 25 Nov. 10:43. 2019
Location: John Muir Elementary School/Smash
Title: Pest Assessment for Termite Activity.
No. Items: 26

IPM assessment By IPM TECH Pest Management

School: **John Muir Elementary school/ Smash**

Special Instructions/History of Pest Activity: The purpose of the pest assessment is inspect John Muir Elementary school/ Smash for visual Drywood termite activity that has been observed on different classrooms in 2019.

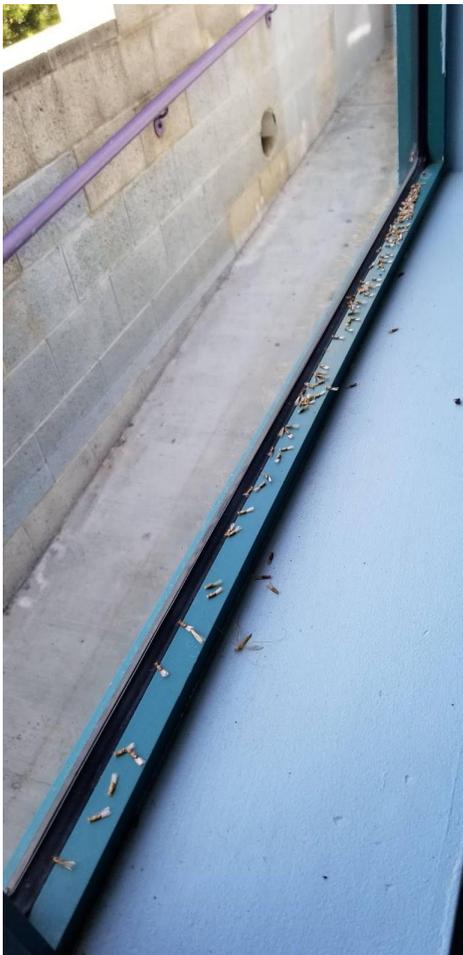
(1)

MPR ROOM
Swarming termites inside MPR.
Window next to the music room.

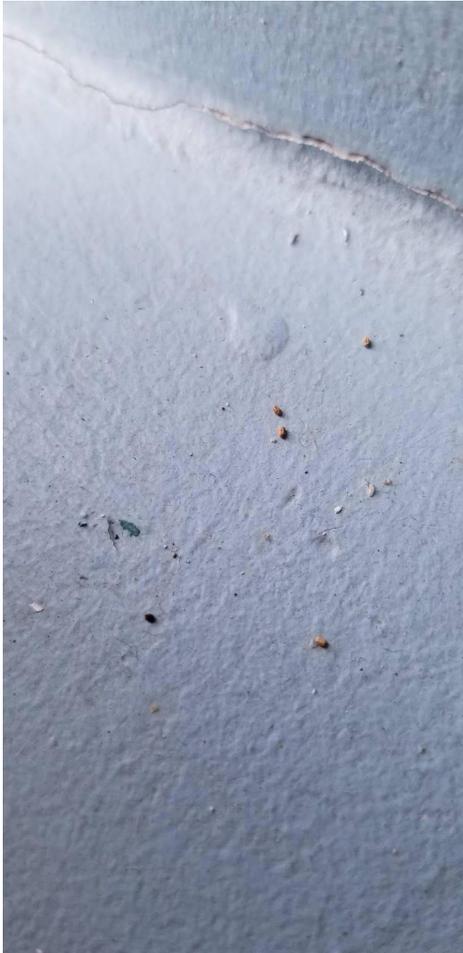
(2)

MPR ROOM

Drywood termites fecal pellets observed inside MPR. Window next to the music room. Fecal pellets are falling down from small kick holes above windows sill.

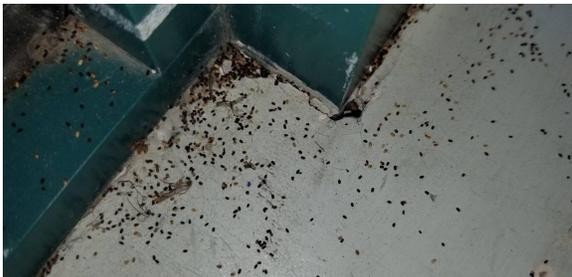
(3)

MUSIC ROOM

Drywood termites fecal pellets inside music room, window next to Drums . Fecal pellets are falling down from small kick holes above windows sill.

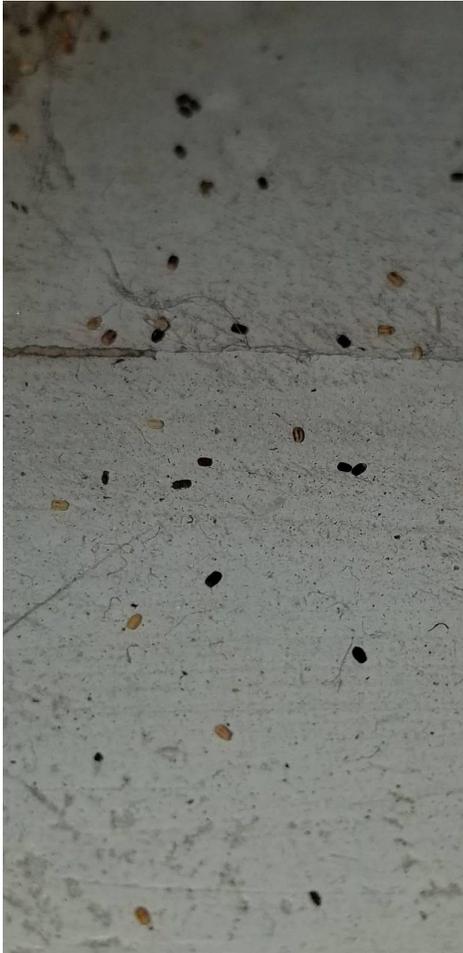
(4)

MUSIC ROOM

Drywood termites fecal pellets inside music room. Window behind piano. Fecal pellets are falling down from small kick holes above windows sill.

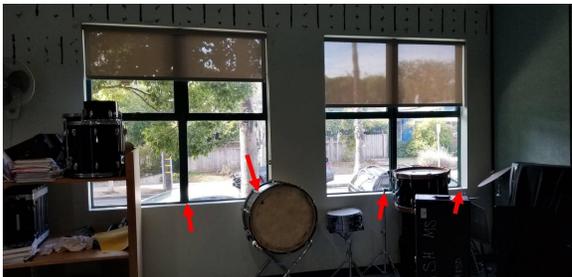
(5)

MUSIC ROOM

Photo showing the location of drywood termite fecal pellets inside music room.

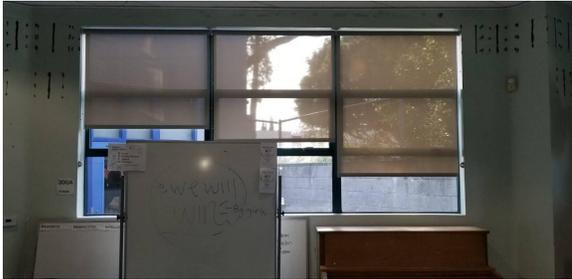
(6)

MUSIC ROOM

Location of the windows with drywood termite pellets inside music room.

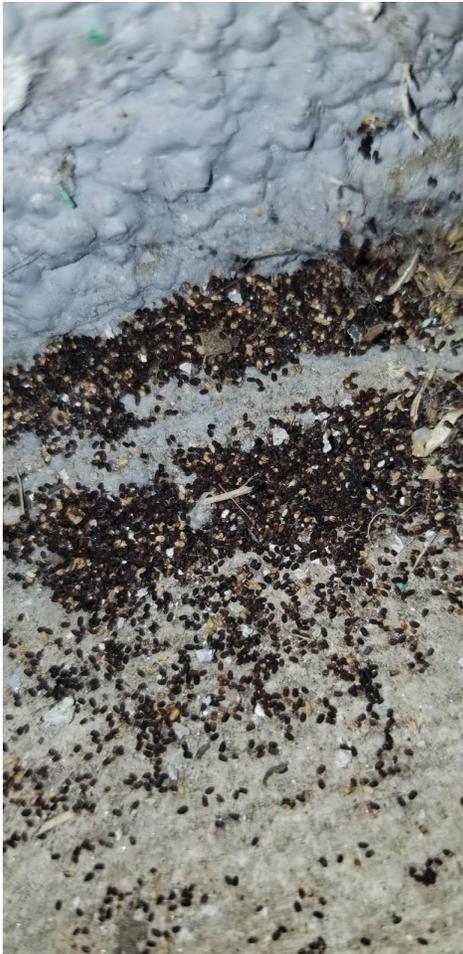
(7)

OUTSIDE MPR ROOM

Windows with drywood termite fecal pellets outside MPR.

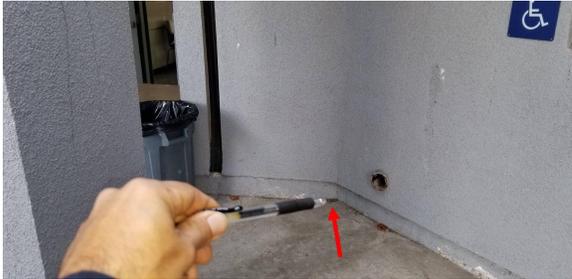
(8)

OUTSIDE MPR ROOM

Location of the Drywood termite fecal pellets observed outside MPR room.

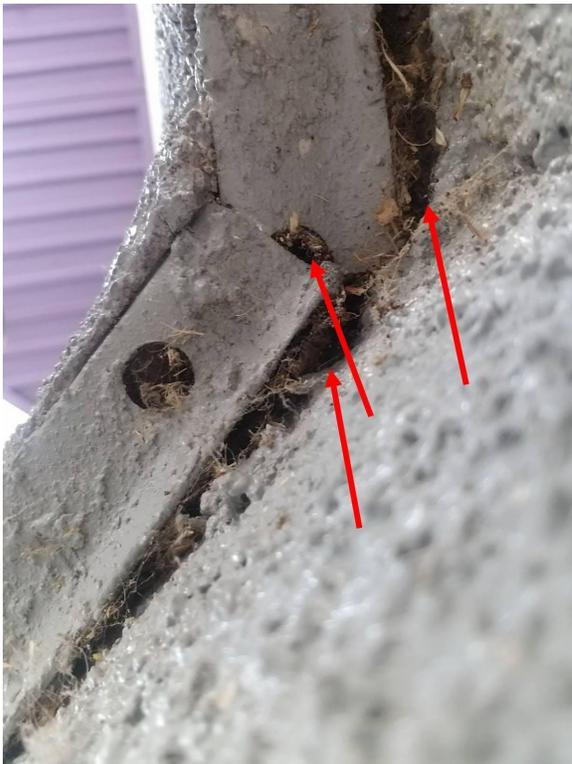
(9)

OUTSIDE MPR ROOM

Drywood Kick out holes outside MPR room.

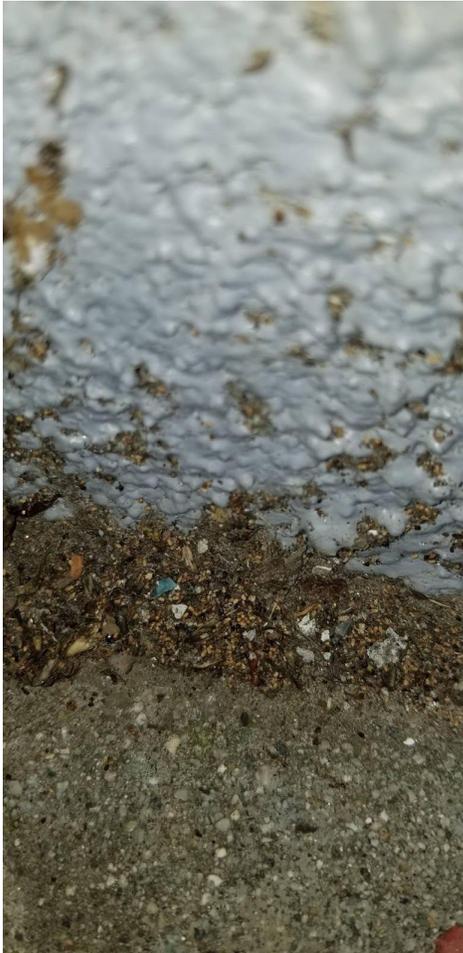
(10)

OUTSIDE MPR ROOM
Drywood termite fecal pellets on
back of MPR.

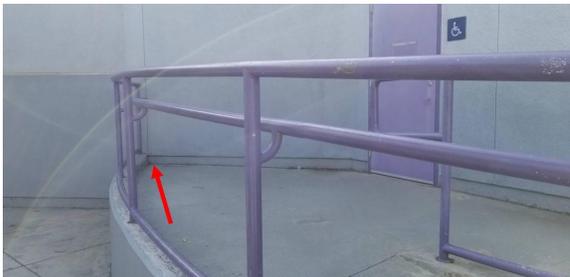
(11)

OUTSIDE MPR ROOM
Location of the drywood termite
fecal pellets outside, back of MPR
room.

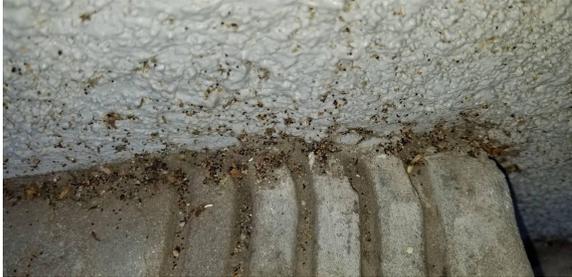
(12)

OUTSIDE MPR ROOM
Drywood termite fecal pellets
under exterior windows outside
MPR.

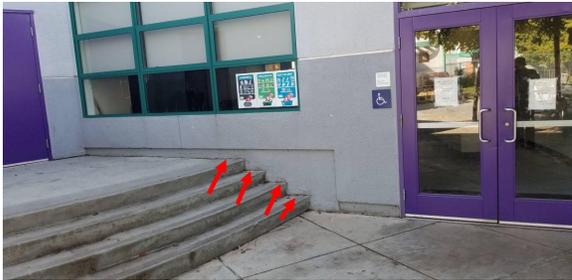
(13)

OUTSIDE MPR ROOM
Location of the Drywood termite
fecal pellets, on exterior windows,
outside MPR.

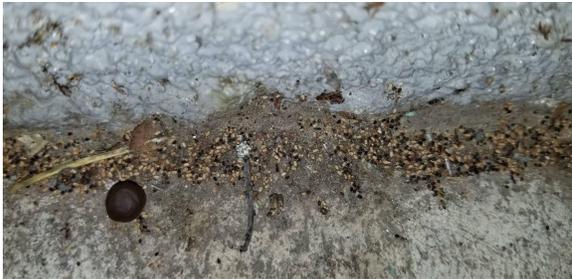
(14)

OUTSIDE KITCHEN
Drywood termite fecal pellets
observed on the left side of the
kitchen.

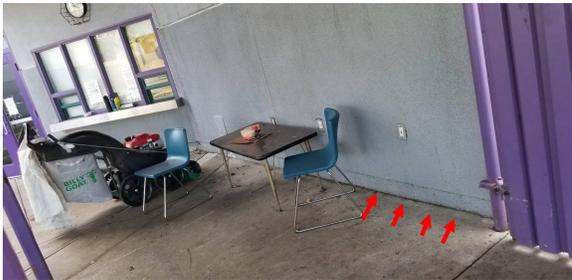
(15)

OUTSIDE KITCHEN
Location of the Drywood termite
fecal pellets observed on the left
side of the kitchen.

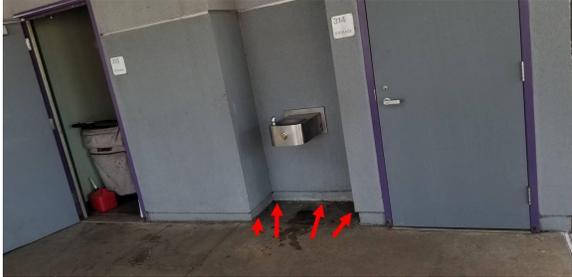
(16)

OUTSIDE CLASSROOM 313 & 314
Drywood termite fecal pellets
observed underneath the water
fountain between rooms 313 and
314.

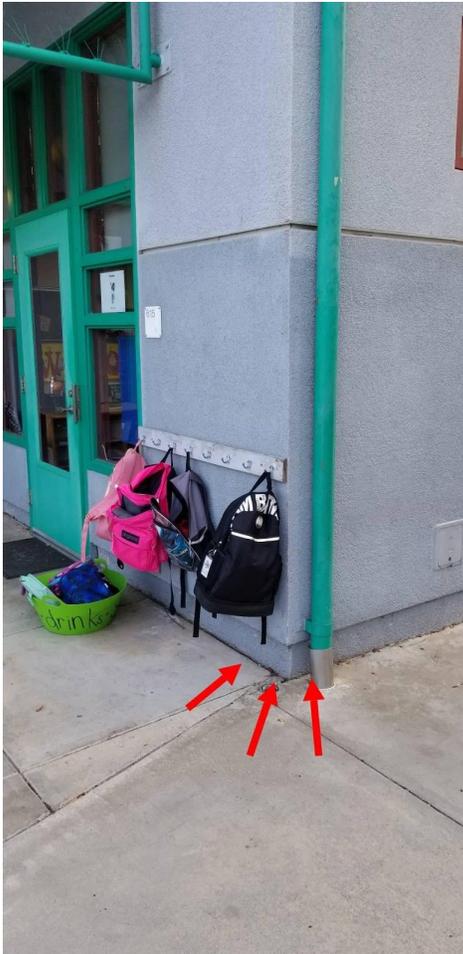
(17)

OUTSIDE CLASSROOM 615
Drywood termite fecal pellets and
kick holes observed outside wall,
on the corner of room 615.

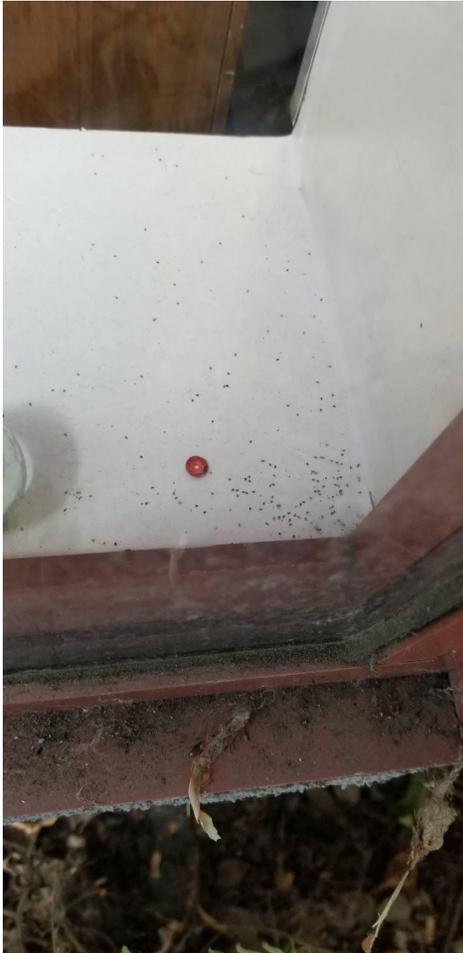
(18)

INSIDE CLASSROOM 600
Drywood termite fecal pellets and
kick holes observed on base of
windows inside room 600

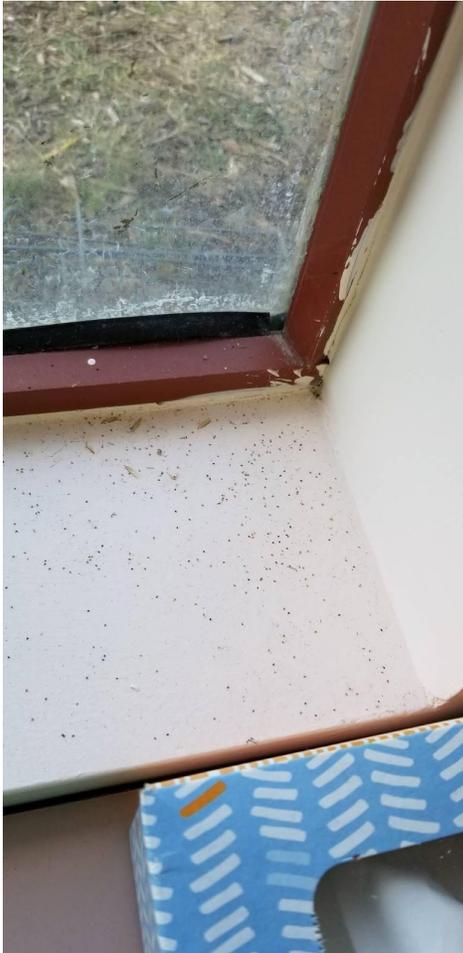
(19)

INSIDE CLASSROOM 605

Drywood termite fecal pellets
observed on the left on base of
window inside room 605.

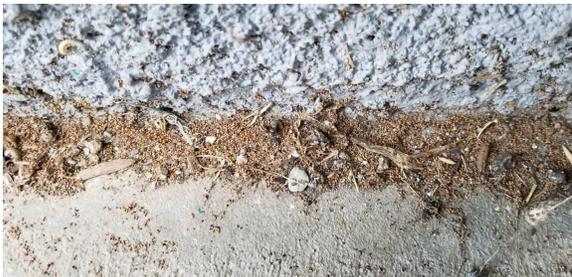
(20)

OUTSIDE CLASSROOM 610

Drywood termite fecal pellets and
kick holes observed outside room
610.

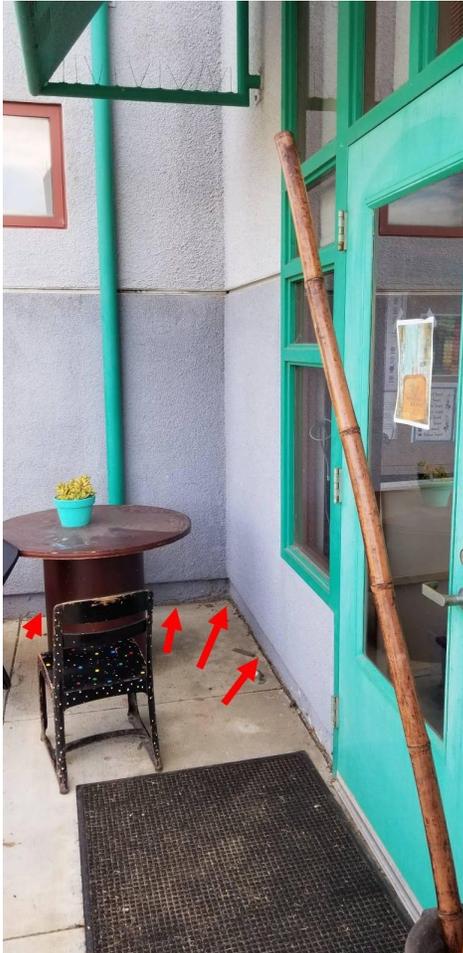
(21)

OUTSIDE CLASSROOM 610
Location of drywood termite fecal pellets Outside room 610.

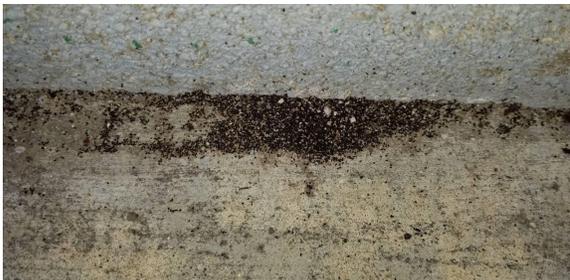
(22)

OUTSIDE CLASSROOM 200
Observed A pile of drywood termite fecal pellets on the floor, outside room 200.

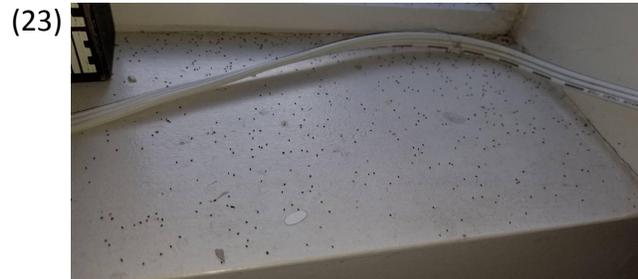
OUTSIDE CLASSROOM 205
Drywood termite fecal pellets and kick holes observed on the inside room 205, by the window next to the exit room.

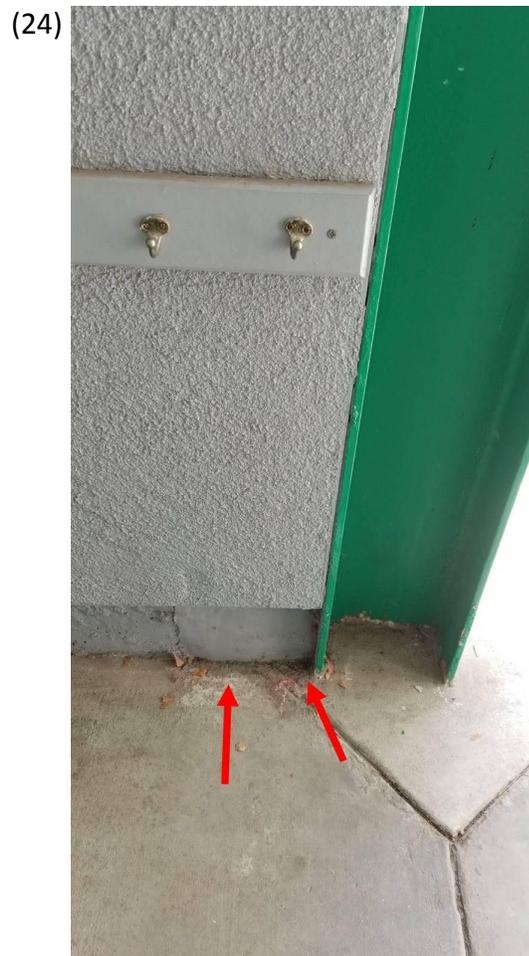
OUTSIDE CLASSROOM 520
Drywood termite fecal pellets observed against the wall, outside room 520.

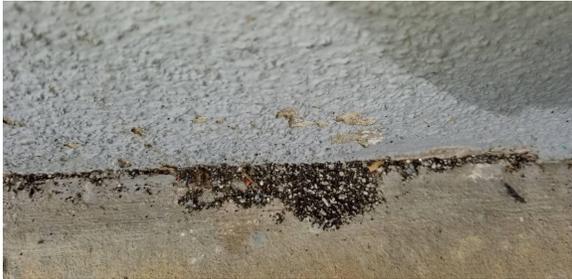
(25)

OUTSIDE BY THE STAIRS

Drywood termite fecal pellets observed on stairs next to mechanical room 416, in front of the small yard.

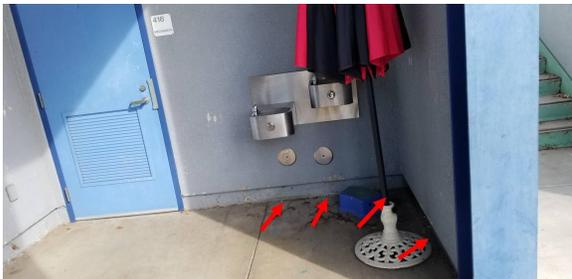
(26)

OUTSIDE MECHANICAL ROOM 416

Drywood termite fecal pellets observed under the water fountain outside mechanical room 416.

- Cleaning and removing old fecal pellets after the treatment is rendered will help tremendously to identify new activity after treatments.
