TOTAL DRINKING FOUNTIAN THROUGH OUT DISTRICT

McKinley ES Wall Mounted Drinking Fountain Inspection Survey

McKinley ES INTERIOR & EXTERIOR Drinking Fountain Inspection Survey

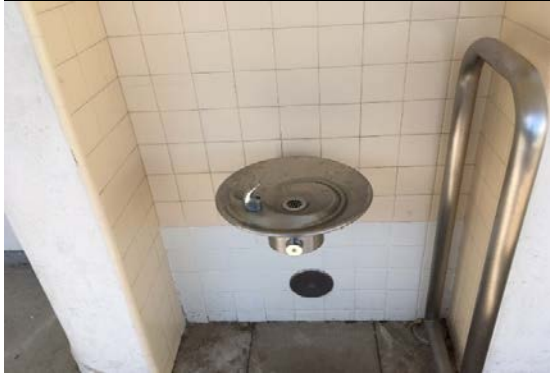
Picture #1

Location	Brand	Year	Type	Operable	Pic Ref #	Ada	Int/Ext	Condition
REAR OF ATTENDANCE OFFICE	HAWS		STANDARD	NO	1	YES	EXTERIOR	REPLACE
BUILDING I-CORRIDOR	HAWS		STANDARD	NO	2	YES	EXTERIOR	REPLACE
BUILDING S-CORRIDOR	HALSEY/TAYLOR		STANDARD	YES	3	YES	EXTERIOR	OUTDATED
BUILDING J-MUSIC	HAWS		STANDARD	YES	4	NO	EXTERIOR	OUTDATED
CHILD CARE	HAWS		PEDESTAL	YES	5	YES	EXTERIOR	REPLACE
CHILD CARE-PLAYGROUND	HAWS		PEDESTAL	YES	6	YES	EXTERIOR	REPLACE
BUILDING G	HAWS		STANDARD	YES	7	YES	EXTERIOR	GOOD
REAR COURTYARD	HAWS		PEDESTAL	YES	8	YES	EXTERIOR	OUTDATED
CAFETERIA	?		STANDARD	YES	9	YES	EXTERIOR	REPLACE
CAFETERIA DINING AREA	HAWS		STANDARD	YES	10	YES	INTERIOR	GOOD
CAFETERIA DINING AREA	HAWS		STANDARD	YES	11	YES	INTERIOR	GOOD
BUILDING C-GYM	HAWS		STANDARD	YES	12	YES	EXTERIOR	GOOD
BUILDING C-GYM BY BOYS LOCKER RM	HAWS		STANDARD	YES	13	YES	EXTERIOR	OUTDATED
BOYS LOCKER ROOM HALLWAY	HAWS		STANDARD	YES	14	YES	INTERIOR	GOOD

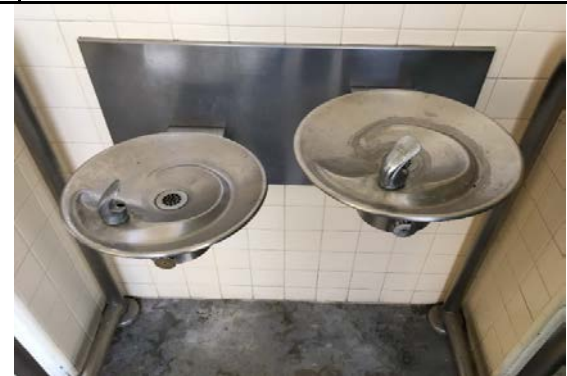
Picture #15

BUILDING P-CORRIDOR	HAWS		STANDARD	NO	15	YES	EXTERIOR	REPLACE
BUILDING O-CORRIDOR	HAWS		STANDARD	NO	16	YES	EXTERIOR	REPLACE
ADMINISTRATION CORRIDOR	HAWS		STANDARD	NO	17	YES	EXTERIOR	REPLACE
FIELD NEAR CAFETERIA	HAWS		PEDESTAL	YES	18	YES	EXTERIOR	OUTDATED
FIELD NEAR BASKETBALL COURTS	HAWS		PEDESTAL	NO	19	YES	EXTERIOR	REPLACE

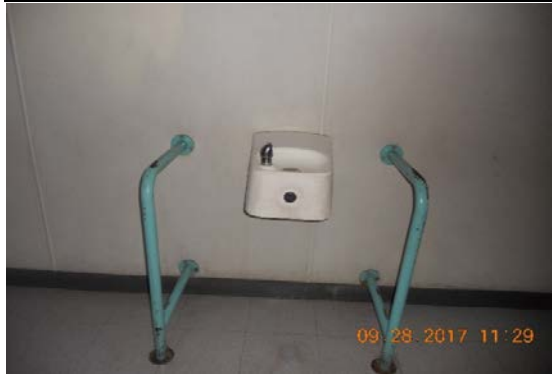
Picture #1

Lincoln MS Wall Mounted Drinking Fountain Inspection Survey								
Location	Brand	Year	Type	Operable	Pic Ref #	Ada	Int/Ext	Condition
GYM HALLWAY	SUNROC		STANDARD	YES	1	YES	INTERIOR	OUTDATED
GIRLS LOCKER ROOM	SUNROC		STANDARD	YES	2	YES	INTERIOR	OUTDATED
GYM NEAR VENDING	ELKAY		COMBO	YES	3	YES	EXTERIOR	GOOD
POOL	SUNROC		STANDARD	YES	4	YES	INTERIOR	OUTDATED
NEAR ROOM 314	SUNROC		STANDARD	YES	5	YES	EXTERIOR	OUTDATED
NEAR ROOM 324	HAWS		STANDARD	YES	6	YES	EXTERIOR	OUTDATED
STAFF LOUNGE	SUNROC		STANDARD	YES	7	YES	INTERIOR	OUTDATED
CAFETERIA	HAWS/ELKAY		COMBO	YES	8	YES	EXTERIOR	OUTDATED
1ST FLR MAIN BLDG GIRLS RR	SUNROC		STANDARD	YES	9	YES	INTERIOR	OUTDATED
1ST FLR MAIN BLDG BOYS RR	ELKAY		COMBO	YES	10	YES	INTERIOR	GOOD
2ND FLR MAIN BLDG GIRLS RR	ELKAY		COMBO	YES	11	YES	INTERIOR	GOOD
2NS FLR MAIN BLDG BOYS RR	HAWS		STANDARD	YES	12	YES	INTERIOR	GOOD
AUDITORIUM MEN RR	HAWS		STANDARD	YES	13	YES	INTERIOR	GOOD
AUDITORIUM WOMAN RR	HAWS		STANDARD	YES	14	YES	INTERIOR	GOOD

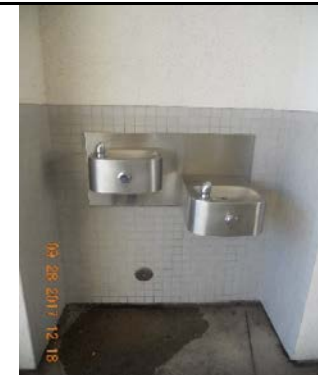
Picture #15

NEAR CHORUS ROOM	HAWS		STANDARD	YES	15	YES	EXTERIOR	GOOD
VESIBULE #2	HAWS		STANDARD	YES	16	YES	INTERIOR	GOOD

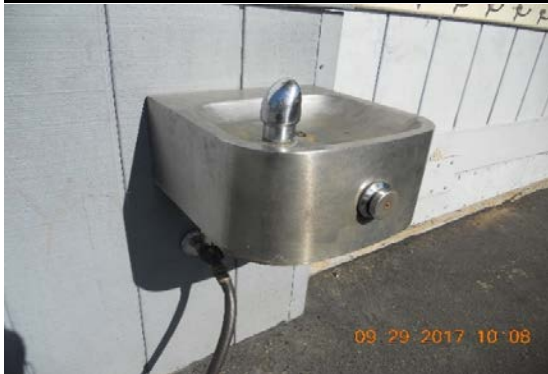
Picture #1

<i>Location</i>	<i>Brand</i>	<i>Year</i>	<i>Type</i>	<i>Operable</i>	<i>Pic Ref #</i>	<i>Ada</i>	<i>Int/Ext</i>	<i>Condition</i>
BUNGALOW A	SUNROC		STANDARD	YES	1	YES	EXTERIOR	OUTDATED
NEAR ROOM 620	HAWS		STANDARD	YES	2	YES	EXTERIOR	GOOD
NEAR ROOM 670	HAWS		STANDARD	YES	3	YES	EXTERIOR	GOOD
NEAR ROOM 570	HAWS		STANDARD	YES	4	YES	EXTERIOR	GOOD
NEAR ROOM 520	HAWS		STANDARD	YES	5	YES	EXTERIOR	GOOD
NEAR ROOM 314 STORAGE	HAWS		STANDARD	YES	6	YES	EXTERIOR	GOOD
MPR	HAWS		STANDARD	YES	7	YES	INTERIOR	GOOD
NEAR ROOM 416	HAWS		STANDARD	YES	8	YES	EXTERIOR	GOOD

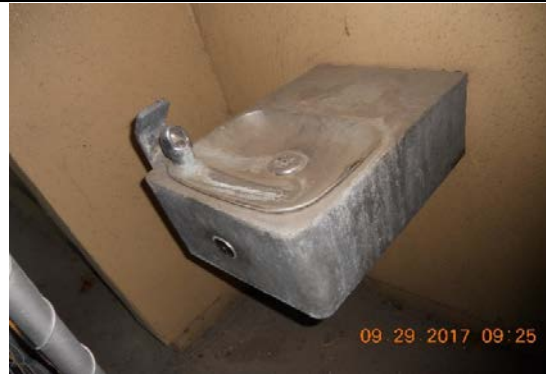
Picture #2

Olympic HS Wall Mounted Drinking Fountain Inspection Survey								
<i>Location</i>	<i>Brand</i>	<i>Year</i>	<i>Type</i>	<i>Operable</i>	<i>Pic Ref #</i>	<i>Ada</i>	<i>Int/Ext</i>	<i>Condition</i>
REAR OF CLASSROOM 307	SUNROC		STANDARD	YES	1	YES	EXTERIOR	OUTDATED
NEAR SCIENCE LAB 100	HAWS		STANDARD	YES	2	YES	EXTERIOR	REPLACE
ROOM 6	HAWS		STANDARD	YES	3	YES	EXTERIOR	OUTDATED
LUNCH AREA	SUNROC		STANDARD	YES	4	YES	EXTERIOR	REPLACE
Olympic HS INTERIOR & EXTERIOR Drinking Fountain Inspection Survey

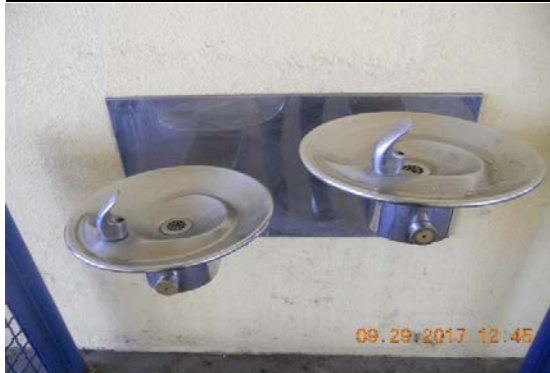
Picture #1

<i>Location</i>	<i>Brand</i>	<i>Year</i>	<i>Type</i>	<i>Operable</i>	<i>Pic Ref #</i>	<i>Ada</i>	<i>Int/Ext</i>	<i>Condition</i>
BUILDING 100	HAWS		STANDARD	YES	1	YES	EXTERIOR	GOOD
BUILDING 400	HAWS		STANDARD	YES	2	YES	EXTERIOR	GOOD
CHILD CARE	HAWS		STANDARD	YES	3	YES	EXTERIOR	GOOD
CAFETERIA	HAWS		STANDARD	YES	4	YES	EXTERIOR	REPLACE
HANDBALL COURTS	GLOBAL TAP		STANDARD	YES	5	YES	INTERIOR	REPLACE
HANDBALL COURTS	HALSEY TAYLOR		STANDARD	YES	6	YES	EXTERIOR	GOOD
PE BUNKER	HAWS		STANDARD	YES	7	YES	EXTERIOR	GOOD
